# Understanding Various Factors that Reduce Heat-Resistant-Alloy Component Life

Jason Wilson - Rolled Alloys, Temperance, Mich.

Choosing the optimum heat-resistant material for a given application will increase the useful component life and keep your maintenance costs under control. This article helps to identify the right material for the job and provides some things to watch for to avoid catastrophic failure.

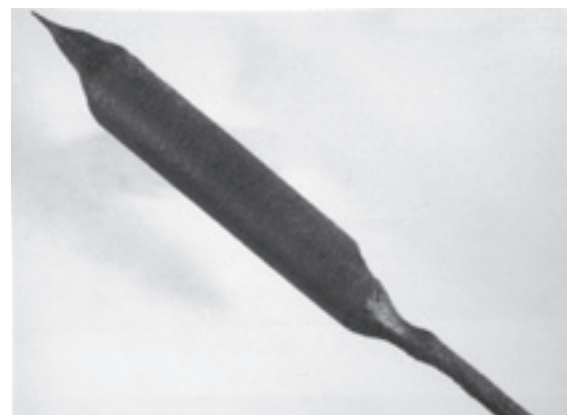
**Fig. 2. 316L round-bar 3/4 inch in diameter exposed to 1800°F in air atmosphere. 316L is suggested to be used only to 1500°F due to scaling. In contrast, its melting point is 2540°F.**

literature. This temperature is typically based upon when the rate of scaling from oxidation becomes unacceptable. It is not based on melting temperature. Most heat-resistant alloys have oxidation limits several hundred degrees below their melting points. Figures 1 and 2 provide suggested alloy temperature limits and show an example of what can occur when pushing an alloy beyond these limits.

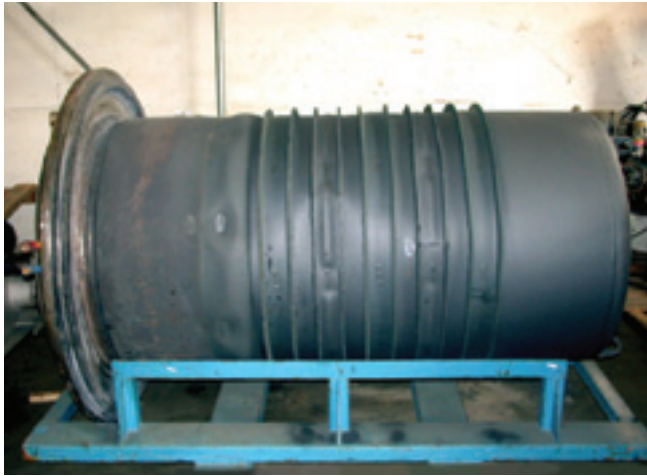
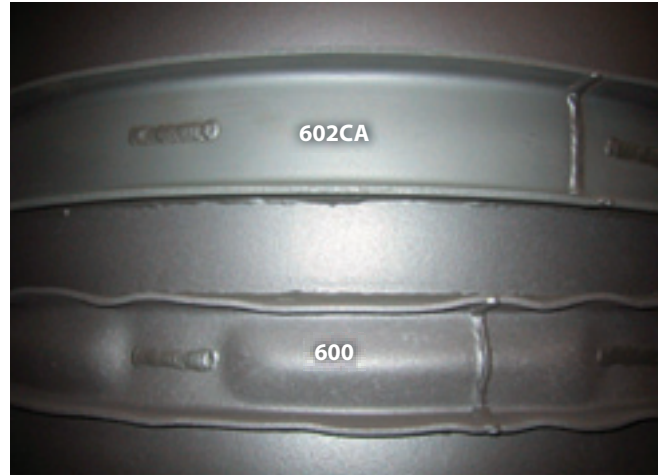
**Figs. 5a. & 5b. Top of a coating retort made of 600 alloy with alternating reinforcement ribs of 600 and RA602 CA. The higher strength of RA 602 CA is evident in the close-up view. Retort wall temperatures are between 2000°-2100°F.**

to cost savings. Figures 5a and 5b show the original design of a coating retort with significant external reinforcement ribs. The higher strength of RA 602 CA allowed the fabricator to eliminate the external reinforcements completely. The simplified design is lower cost than the more complex alloy-600 fabrication, and the furnace load sees more even heat distribution, allowing better process control.

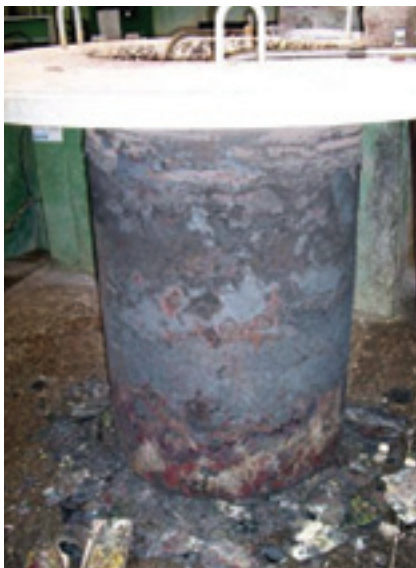
**Fig. 7. Example of scaling happening on the outside of a salt pot after two weeks in service. The previous pot lasted over 15 years. The salt temperature was below 1300°F.**

of this is the erratic service life of salt pots. From time to time the insufficient cleaning of spilled salt from the furnace chamber of a salt-pot furnace causes a rapid pot failure. The salt vapors that form in the chamber upon heating are very aggressive and cause a loose porous oxide scale to form on the surface. This scale is nonprotective and prone to rapid spalling.

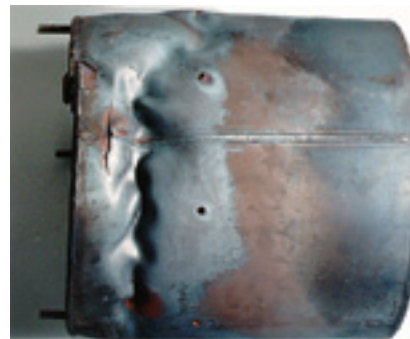
**Fig. 8. This burner-can is a good example of what can happen when uneven heating occurs. In this case, flame impingement occurred during a low-fire condition.**

The burner-can shown in Fig. 8 shows what can occur with uneven heating. During low fire the burner flame impinged on the walls of the burner-can. The shiny glazed scale where the can has distorted indicates

high heat exposure. The other areas of the can operated at much lower temperatures. The area with flame impingement was restrained from expanding by the cooler areas of the can. These cooler areas are also stronger because of their lower temperature. Since expansion of the hot spot was restricted, it buckled to relieve the stress.

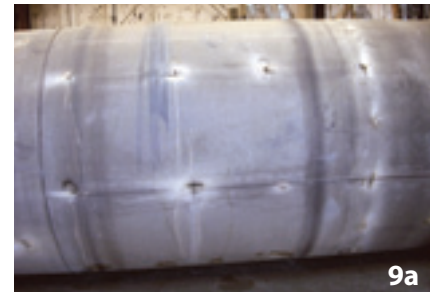
**Fig. 9a. & 9b. Example of a calciner unit that suffered cracking of the shell. This was a result of temperature differentials between the shell and internal flights.**

In another example, a calciner shell suffered cracking that occurred in a definite pattern. This is shown in Fig. 9a. Cracks were found to occur at the ends of each internal flight as shown in Fig. 9b. The cause of this cracking is that the calciner is externally heated. The flights are heated by conducted heat from the shell and are in more contact with the cool product being processed through the calciner. As a result, the flights operate at a lower temperature than the shell. As the hotter, weaker shell tries to expand, the cooler, stronger flight restrains it. This results in the shell cracking under the stress. In this case, one suggestion would be to not solidly weld the flights. It is instead recommended to weld the flights to the shell only at the center, leaving the ends free so as not to restrict the shell from expanding and contracting. **IH**
