### The Erosion Corrosion Resistance Of Zeron 100

<b>Division</b>	Engineering
<b>Job No.</b>	
<b>Reference No.</b>	OC
<b>Report No:</b>	TN781R3
<b>Iss No.</b>	4
<b>Date:</b>	Dec 2008

## THE EROSION CORROSION RESISTANCE OF ZERON 100

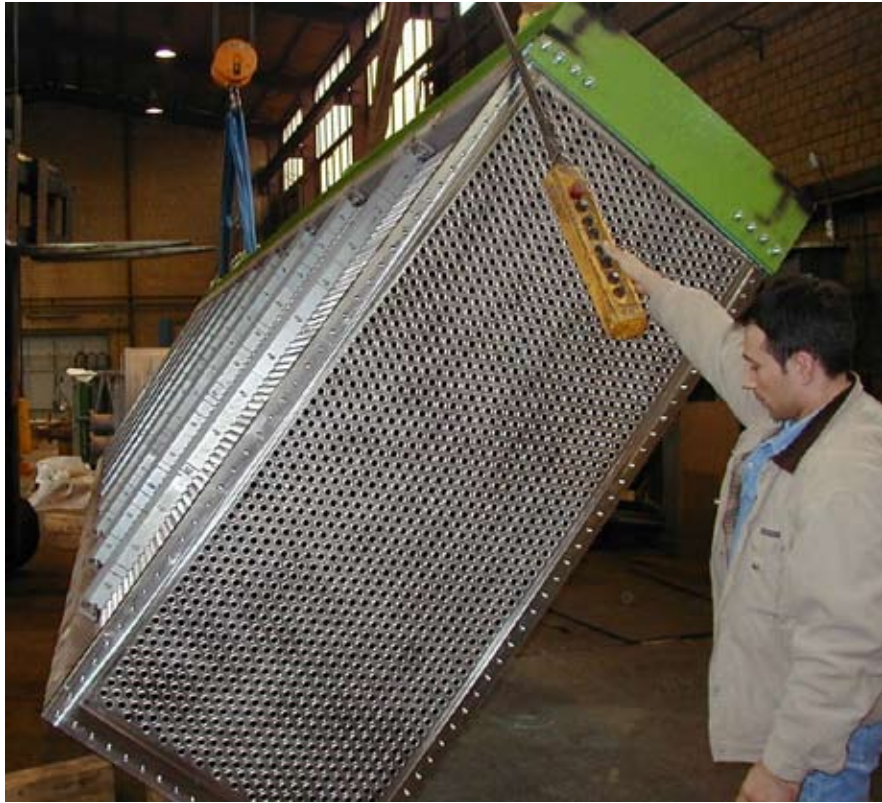
FIGURE 1 Zeron 100 heat exchanger supplied to BOC Cantarell to handle seawater with a high suspended solids content.

The high resistance of Zeron 100 to erosion by silt and sand was used to advantage by the BOC Cantarell plant in Mexico. The seawater for cooling is taken from a shallow bay and the bottom gets stirred up during tropical storms. This means that for several days after a storm there is a high solids burden in the water. The solids are mostly sand and gravel with a peak content of ~50,000 mg/l. The original heat exchangers and seawater pumps were copper alloys and they were suffering severe erosion corrosion. RA Materials won the order to replace the 28 heat exchangers with ones in Zeron 100. At the same time, the aluminium bronze pumps were replaced with eight Zeron 100 pumps feeding the four trains. The cases for these were fabricated from wrought Zeron 100, while the impellers were castings. The Zeron 100 has been in service since 2003 with excellent performance. Figure 1 shows one of the Zeron 100 heat exchangers supplied to Cantarell.

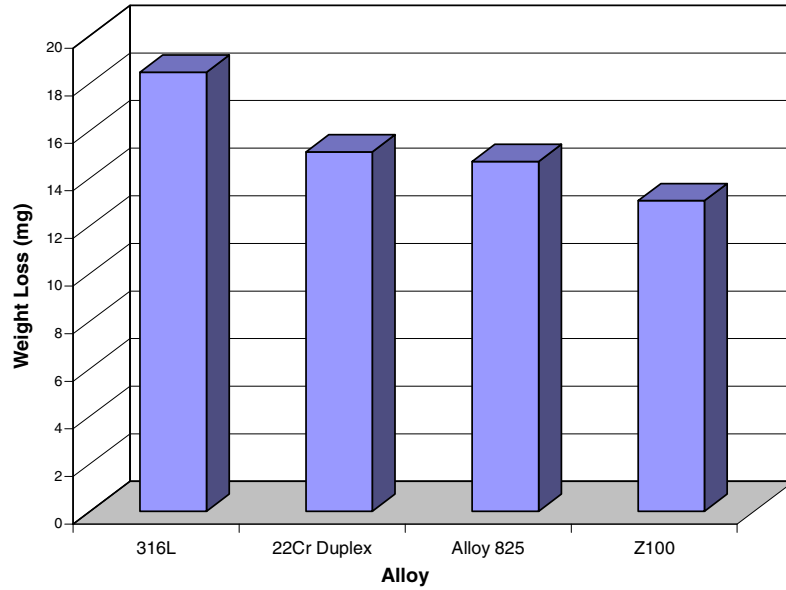
**FIGURE 2 Weight loss of some stainless steels in an acid brine (pH3.5) plus 1,000mg/l sand at 40m/s**

In oil-carrying pipelines the presence of sand can also lead to severe erosion. The presence of CO<sub>2</sub> results in low pH values, sometimes below 4. A number of materials were evaluated in the pin erosion test rig described above (3) under the following conditions.

Chloride	- 25,000 mg/l
Sand	- 640 mg/l
Temperature	- 55°C
pH	- 3.5
Velocity	- 40 m/sec

The results for the average weight loss of duplicate test pieces are shown in Figure 2. The results clearly show the superior resistance to erosion corrosion of Zeron 100 compared to other alloys used in oil and gas process lines.

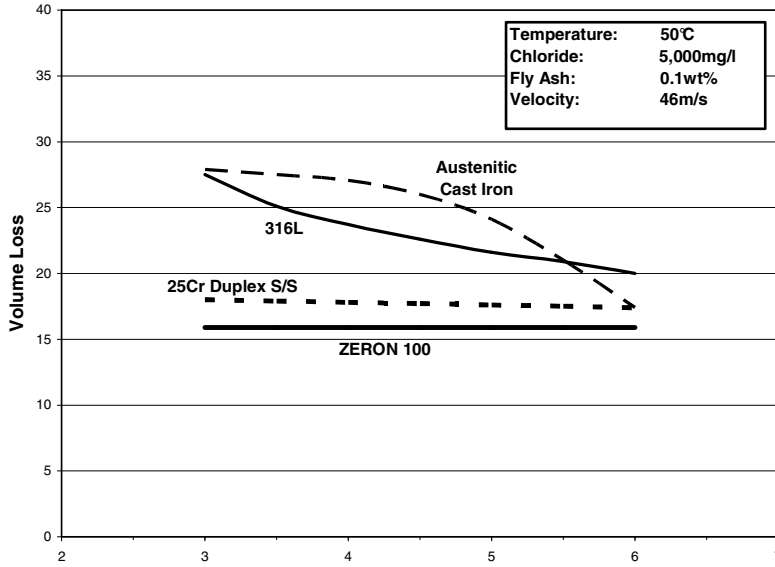
**FIGURE 4 Pin erosion rig test results in a simulated FGD slurry**

Pin erosion tests were conducted on some candidate alloys for the slurry handling system (3). Figure 4 shows the volumetric metal loss over a range of pH values. The erosion loss for both 25% Cr duplex and Zeron 100 was independent of pH over the range

studied. The superior performance of Zeron 100 over not only 316L and austenitic cast iron, but also 25% Cr duplex stainless steel (PREN 35) can clearly be seen.

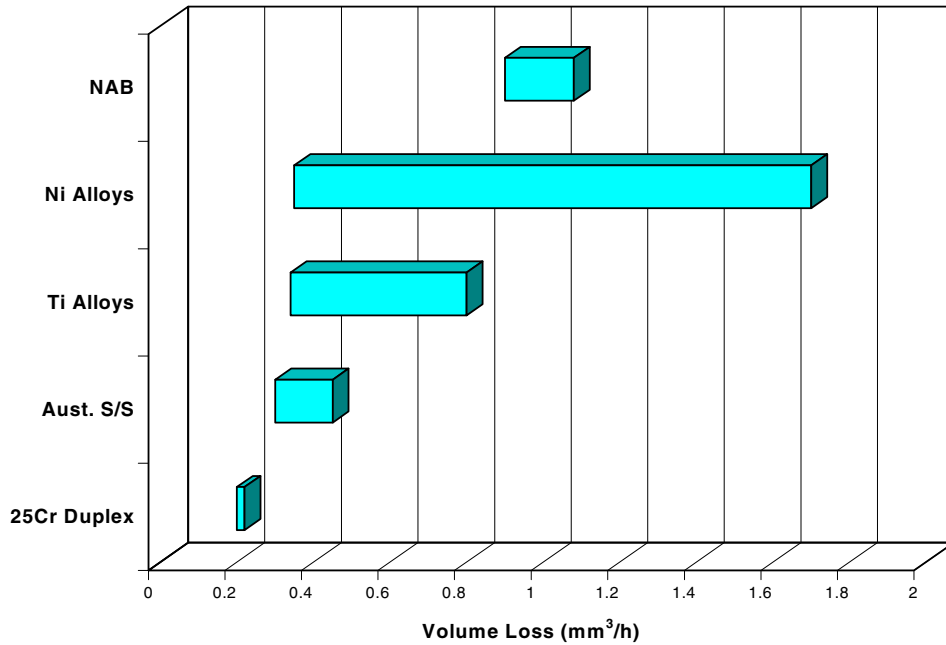
**FIGURE 5 Cavitation volume loss rate at 40m/s in natural seawater (Ref 6)**

Cavitation occurs where there is a sudden pressure drop in a system. This results in the formation of vapour cavities that migrate along the pressure gradient and eventually implode on the metal walls. The energy release can then lead to loss of metal. Cavitation often occurs in high velocity systems and can be linked with erosion corrosion. Typical sites for cavitation are in pumps or after partly throttled valves. Figure 5 shows some cavitation data generated by the Royal Navy in a flow loop in natural seawater (6). The results clearly show the superior performance of superduplex stainless steel compared with nickel aluminium bronze (NAB) and other alloys commonly used for pumps, such as austenitic stainless steels.
